# rupnikova linija

## DOLINSKA ZAPORA PRED ZALIM LOGOM

## VALLEY BLOCKADE BEFORE ZALI LOG

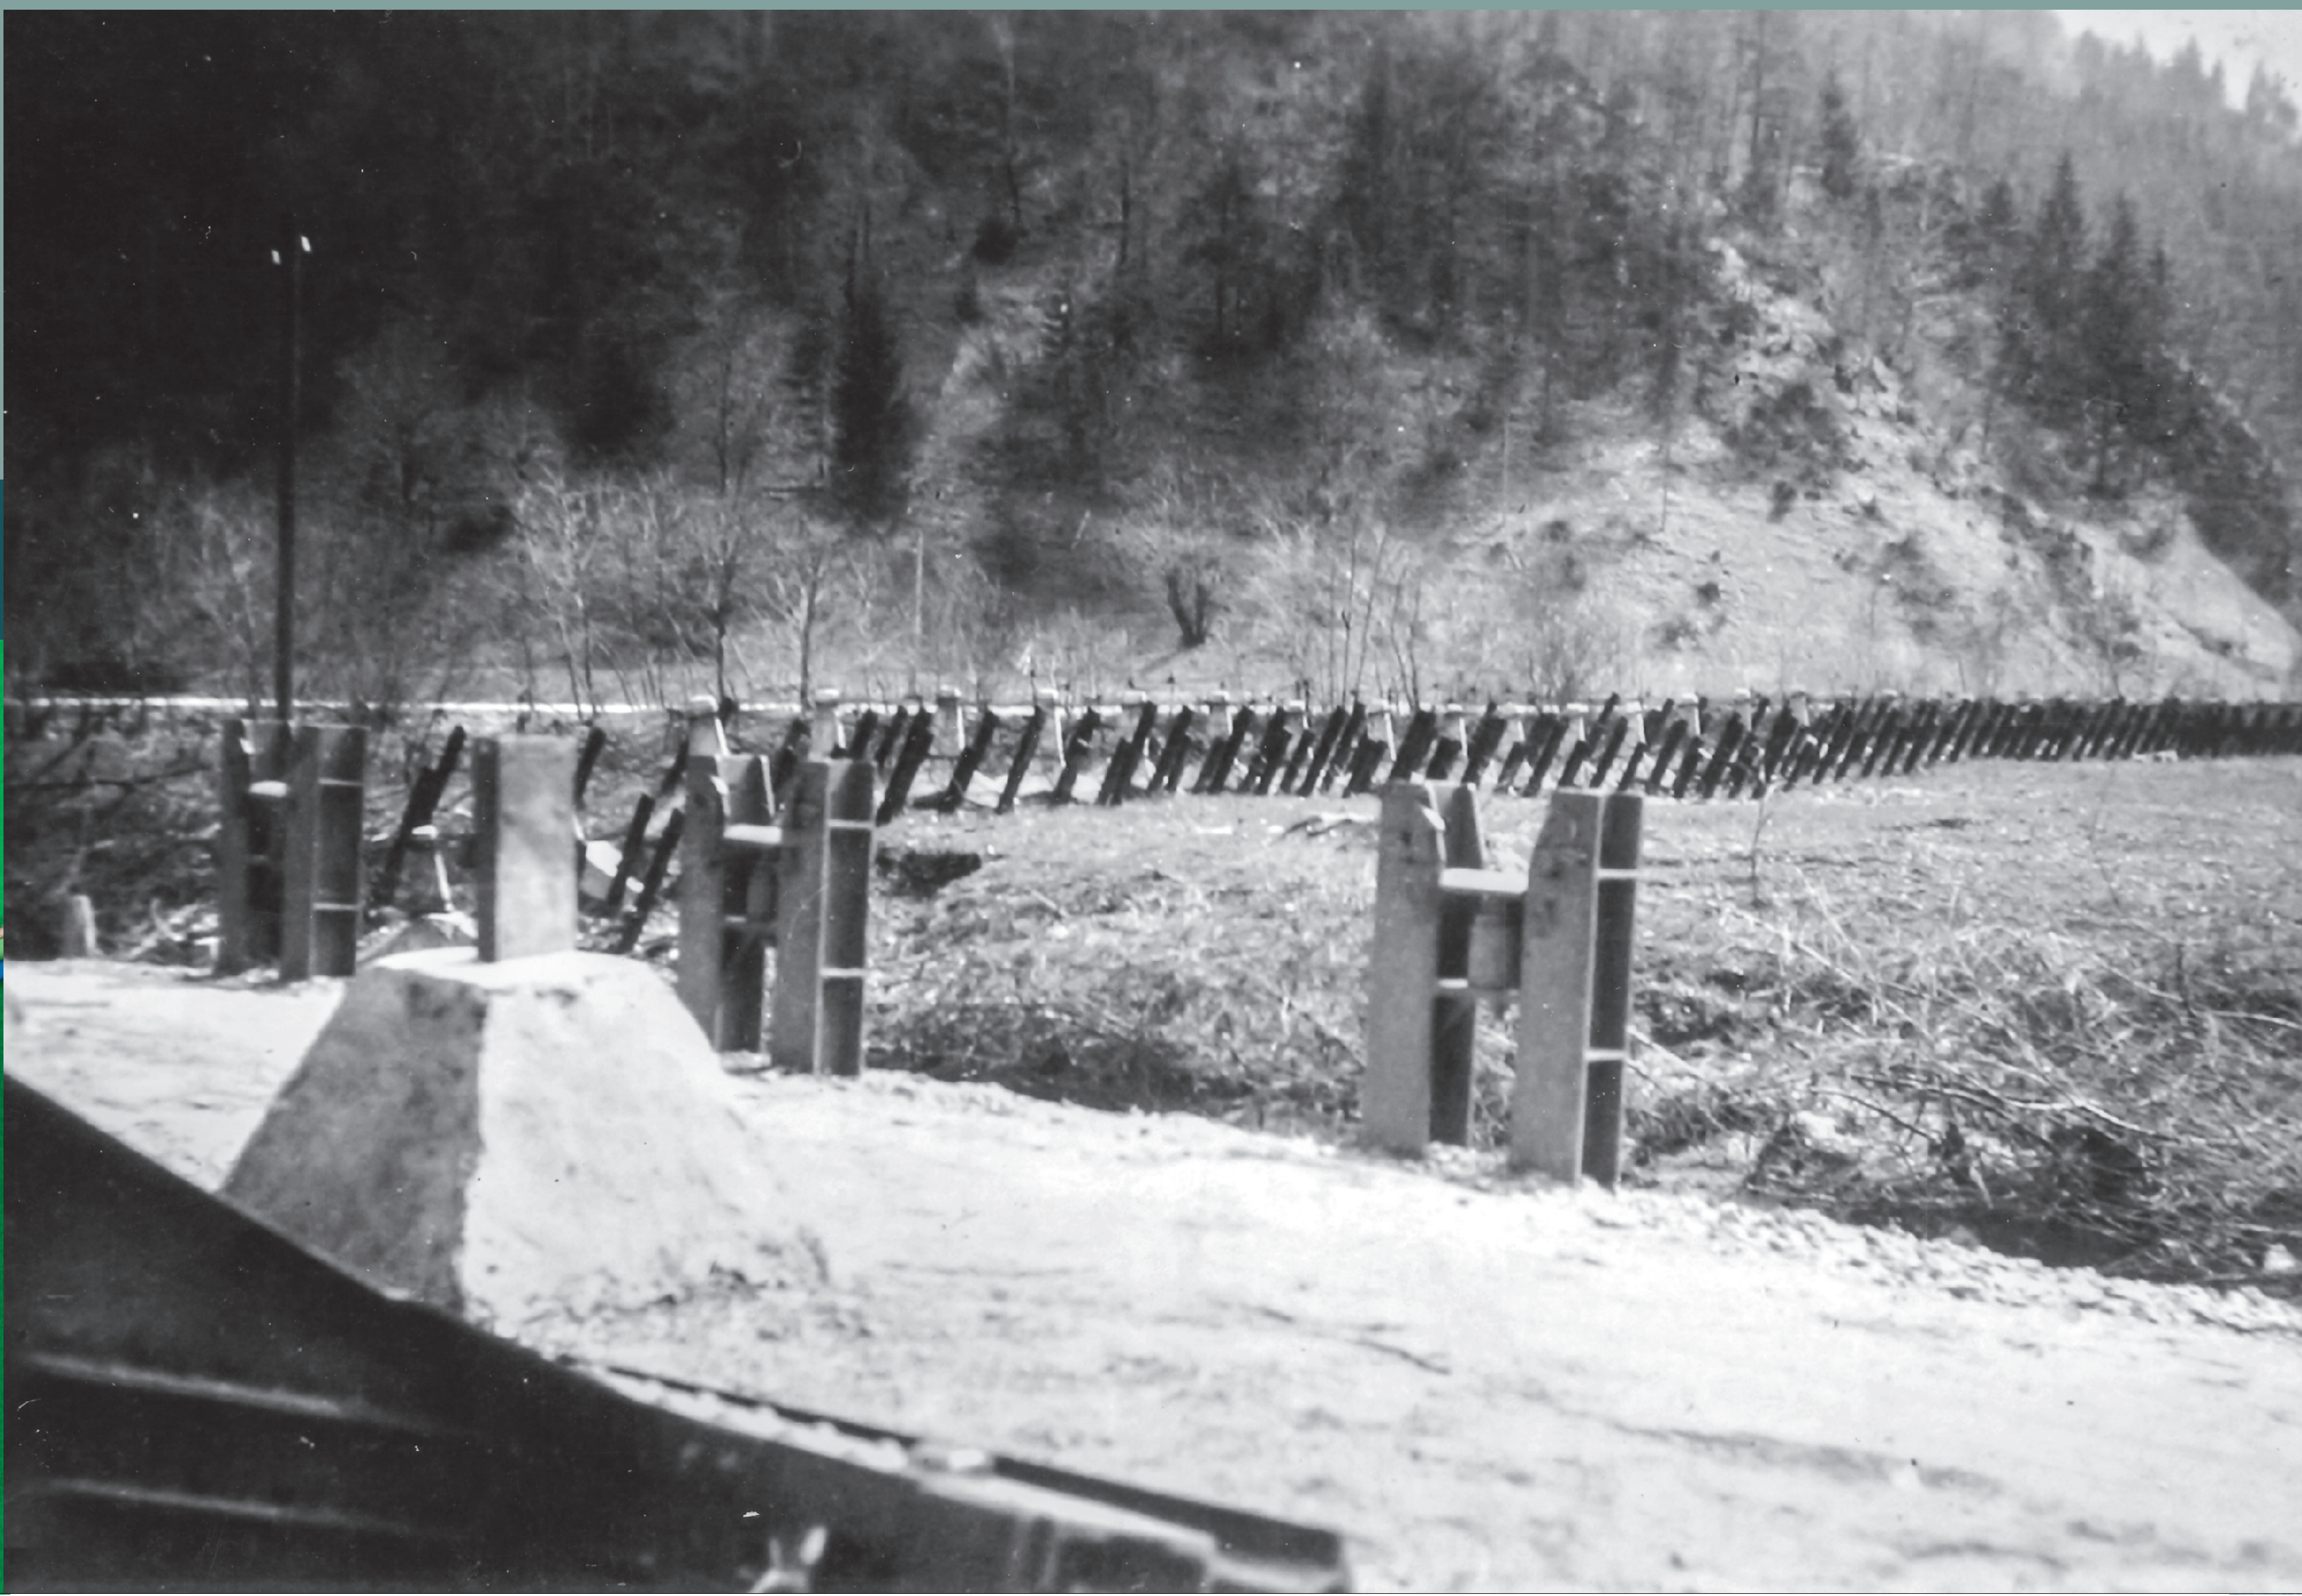
Najdena fotografija (avtor neznan), je bila posneta tik pred ali celo med nemško – italijanskim napadom na ta del Jugoslavije leta 1941. Razsežnost zapore, ki je potekala skozi celotno dolino, je na fotografiji izjemno dobro vidna. Za celotno podobo zapore si moramo na obeh straneh ovir predstavljati še betonski utrdbi in posamezna strojnična gnezda. Omenjeni objekti stojijo še danes, a jih na fotografiji zaradi stojišča fotografa ni mogoče opaziti.

The photograph (by an unknown author) was taken just before or perhaps during the German Italian attack on this part of Yugoslavia in 1941. The size of the barrier that crossed the entire valley is well seen on the photo. But to get the full picture one must also imagine the concrete fortifications and individual machine-gun nests on both sides of the barrier. These structures still stand today, but are not seen on the photo because of the position of the photographer.

Dno ravne pregledne doline, ki se zaključuje s strmimi pobočji, daje braniteljem izrazito prednost. Struga reke Sore se nahaja ob robu doline, kjer je vzporedno po ozki terasi speljana cesta. Prečno na dolino in reko Soro je desni pritok Sore – Davščica, ki poteka po celotni širini doline. Potok Davščica je tako prva ovira, ki zapira dolino, nadgradili so jo še z jeklenimi in betonskimi ovirami (traverze/ježi). Vse ovire so bile med seboj povezane z jeklenicami (preprečeno oz. oteženo odstranjevanje ovir) in prepredene z bodečo žico (ustavljanje pehote). Za bolj uspešno oviranje oklepni enot sta bila zgrajena celo dva betonska bunkerja s protitankovsko oborožitvijo. Vsak na svoji strani doline sta tako pokrivala celotno območje ovir. Izdelana sta tako, da je vanju mogoče zapeljati premični top brez fiksne namestitve. Sporazumevanje med njima je bilo že v tistem času brezžično – s svetlobnimi znaki. Na obeh bunkerjih to prepoznamo po obliki majhnih odprtih, ki sta usmerjeni druga proti drugi.

The bottom of the flat open valley, surrounded by steep slopes, gives the defenders a distinct advantage. The Sora river basin is situated at the edge of the valley, with the road running parallel to it on a narrow terrace. Perpendicularly to the valley and the river Sora is the right tributary of Sora – Davščica, which extends over the entire width of the valley. This makes the Davščica stream the first barrier that closes the valley, but it was further upgraded with steel and concrete barriers (crossbeams/gooseberry). All barriers were connected with wire ropes (preventing or obstructing removal of barriers) and crisscrossed with barbed wires (blocking the infantry). Additionally, two concrete bunkers with anti-tank weapons were built for further obstruction of armoured units. The bunkers overlooked the entire area of barriers, each on its side of the valley. The two structures also enabled mobile cannons without fixed placement to enter the valley. Communication between them was wireless even back then – with light signals. This is clearly seen on both bunkers by the shape of small openings facing each other.
